**TECHNICAL INSTRUCTIONS**

**SAFETY RECALL - 24TA05**

**POTENTIAL AXLE SHAFT SEPARATION**

**CERTAIN 2022-2023 TACOMA**

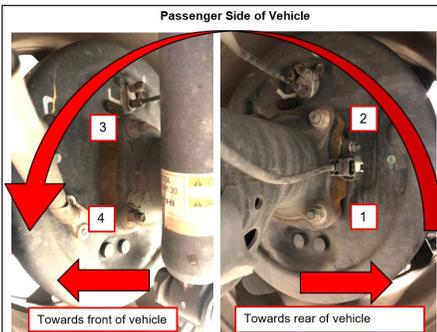
- b. Inspection and repair of passenger side rear axle housing nuts.

- i. Passenger side axle nuts are identified in the corresponding illustration (1 – 4).

**HINT:** When inspecting the passenger side, the rear shock absorber is on the axle tube's front side.

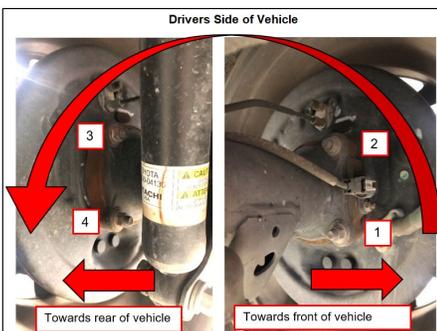
- c. Inspection and repair of driver side rear axle housing nuts.

- i. Driver side axle nuts are identified in the corresponding illustration (1 – 4).

**HINT:** When inspecting the driver side, the rear shock absorber is on the axle tube's rearward side.

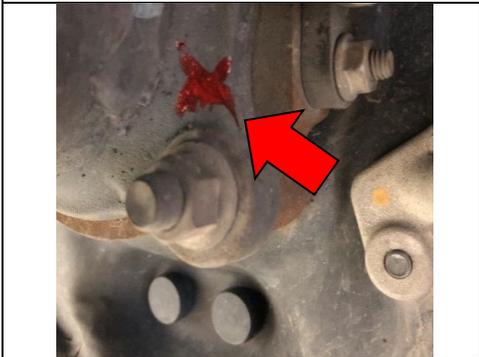
b. Inspect the rear axle housing bolt for damage to its threads.

**Is there any damage to the axle housing bolt threads?**

**YES:** Mark the flange with a red "X" near the rear axle housing bolt with the damaged threads. Then proceed to step c.

**NOTE:** Flanges marked with a red "X" will require the replacement of the rear axle housing bolt in Section IX.

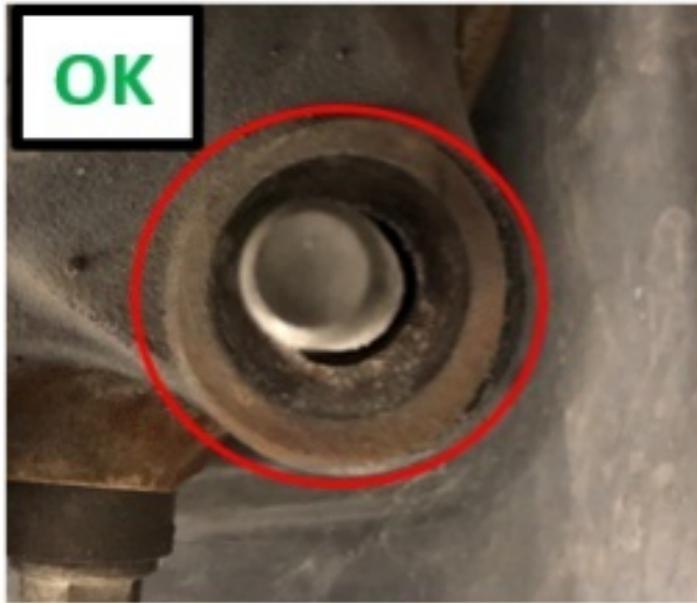
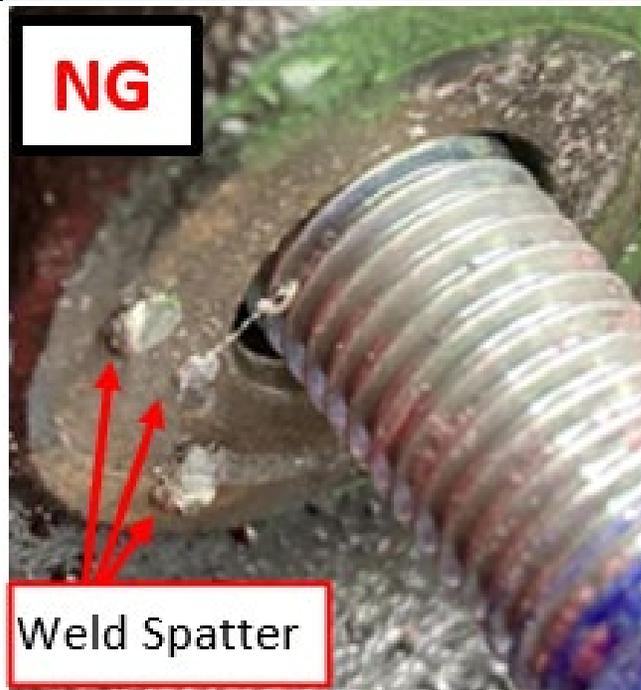
c. Carefully inspect the flat surface behind the axle nut to ensure the area is free of any weld spatter.

HINT: See examples of the "OK" condition vs. "NG" weld spatter condition in the corresponding illustration.

**Does any weld spatter exist?**

OK: Re-install axle nut and torque to specification.

NG: Proceed to Step 4.

**55 N·m {41 ft·lbf}**
