Instructions on how to adapt the current Cali Raised LED Tacoma molle panel to the OEM 2016+ Toyota Tacoma LED bed light system.

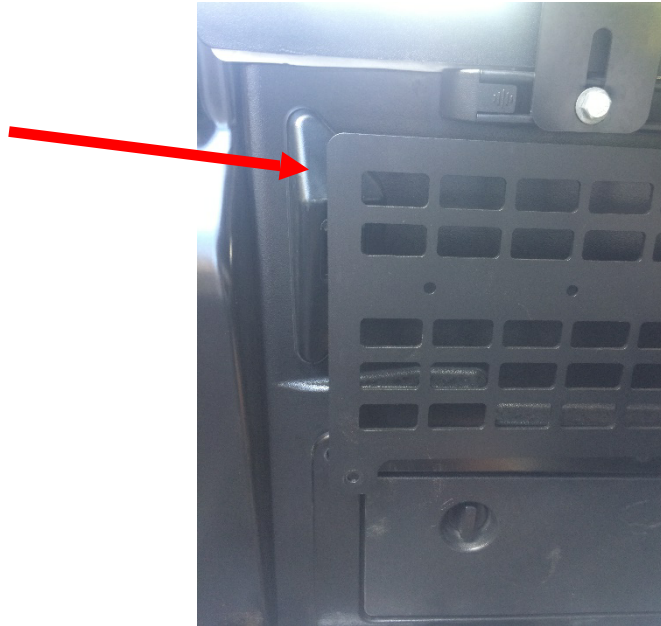
Figure 1 shows the conflict between the factory LED bed light and the Cali Raised LED panel making the driver's side LED light module obsolete and not allowing the panel proper fitment.

*Figure 1 - Molle Panel and LED conflict*

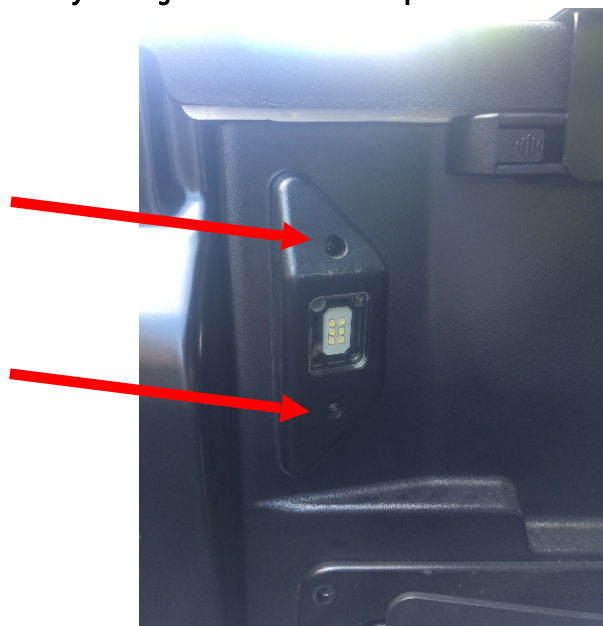
Figure 2 shows the factory bed light and the two Philips screws which secure the light pod to the bed.

*Figure 2 - Screw Placement*

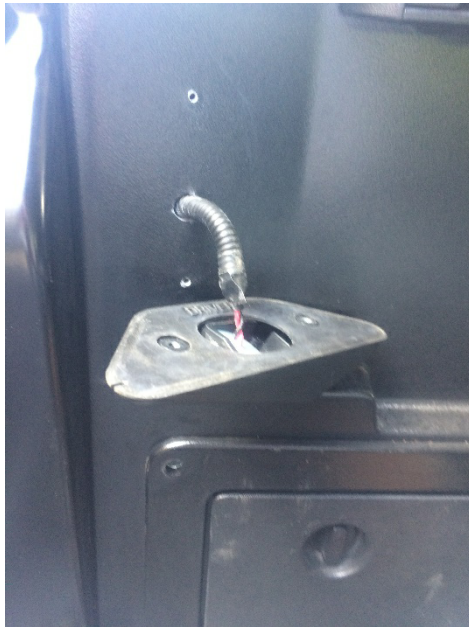
Figure 3 shows the LED pod removed. You can see that it is hard wired and there is a rubber grommet between the LED housing and the bed for prevention of water intrusion.

*Figure 3 - Led Housing Removed*

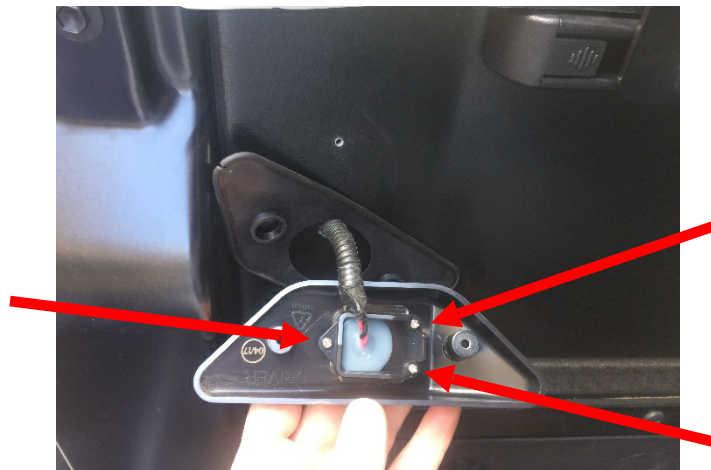
Figure 4 shows the backside of the housing. There is a rubber piece made for weather proofing that needs to be removed prior to exposing the bedside of the LED housing. Once removed the actual LED and associated circuit board is exposed. There are three small Philips screw which must be removed to free the LED and circuit board.

*Figure 4 - LED Housing Backside*

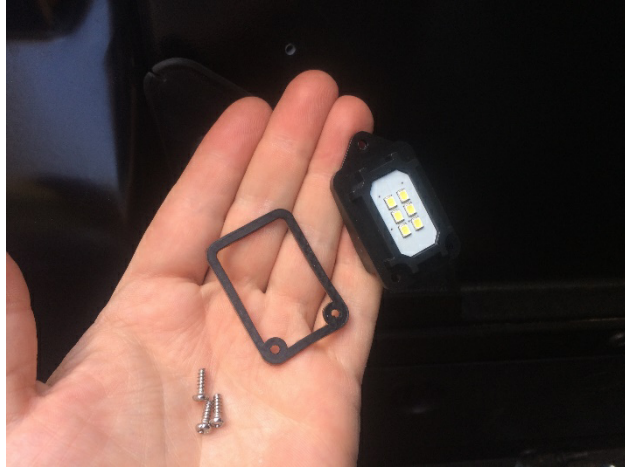
Figure 5 shows the LED circuit removed from the housing along with the associated hardware and a weather grommet that surrounds the LED.

*Figure 5 - LED, Weather Grommet, and Hardware*

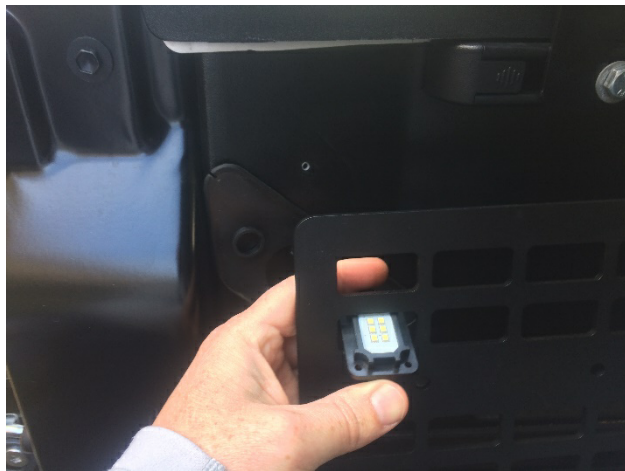
Once the molle panel has been properly assembled and it is ready to mount to the bed side, maneuver the LED circuit through the molle panel cutout as depicted in Figure 6. There is just enough space with ample clearance that the LED should not have to be forced in any way. NOTE: I made a mistake in this picture as you can see the LED housing weather gasket is behind the molle panel. Remove the weather gasket prior to feeding the LED through the molle panel.

*Figure 6 - LED Circuit and Molle Panel*

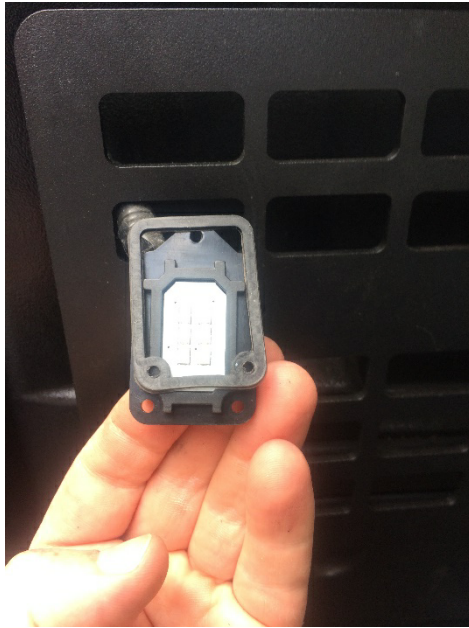
The LED is then reassembled in the reverse order of disassembly. Figure 7 shows the LED weather grommet being reinstalled.

*Figure 7 - LED Weather Grommet*

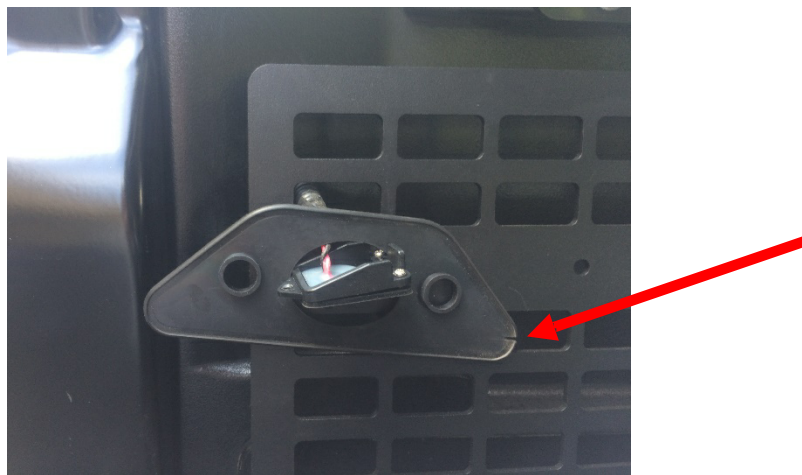
Then feed the LED circuit through the LED housing weather gasket. The driver's side label is oriented towards the bed/molle panel. The side without labeling should face you and the weep/drainage hole (red arrow) will be installed to the housing point down Figure 8.

*Figure 8 - LED Housing Weather Gasket*

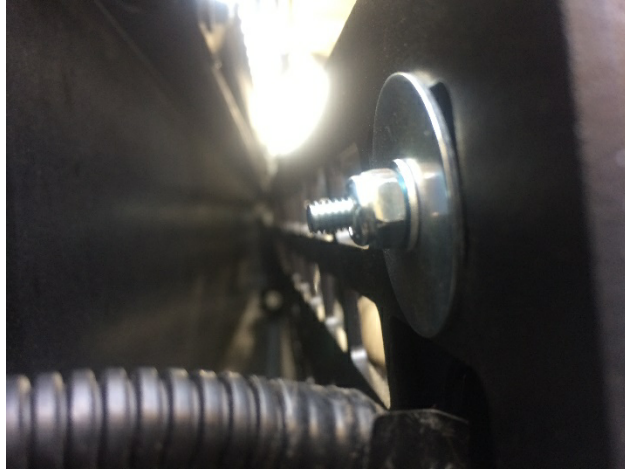
The housing is then placed over the weather gasket and oriented to accept new hardware. I used a M8 machine screw approximately 1.5 cm long with a fender washer and a nyloc nut. I just used what I had lying in the garage. The backside of the molle panel is depicted in Figure 9 with the fore mentioned fixtures.

*Figure 9 - LED Housing Hardware Backside Molle Panel*

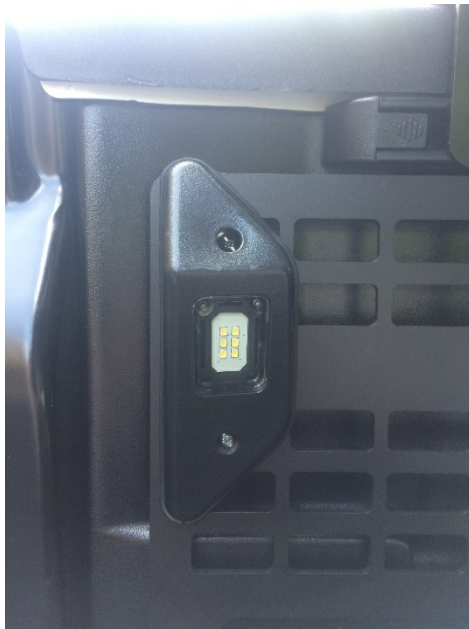
Prior to torquing down the LED housing hardware, reposition the housing as desired. I lined up the housing as parallel to the molle edge as possible and pushed the housing down as far as it would go. In this position it is very close to the original factory position. Figure 10 shows the LED properly installed.

*Figure 10 - LED Housing Installed on Molle Panel*

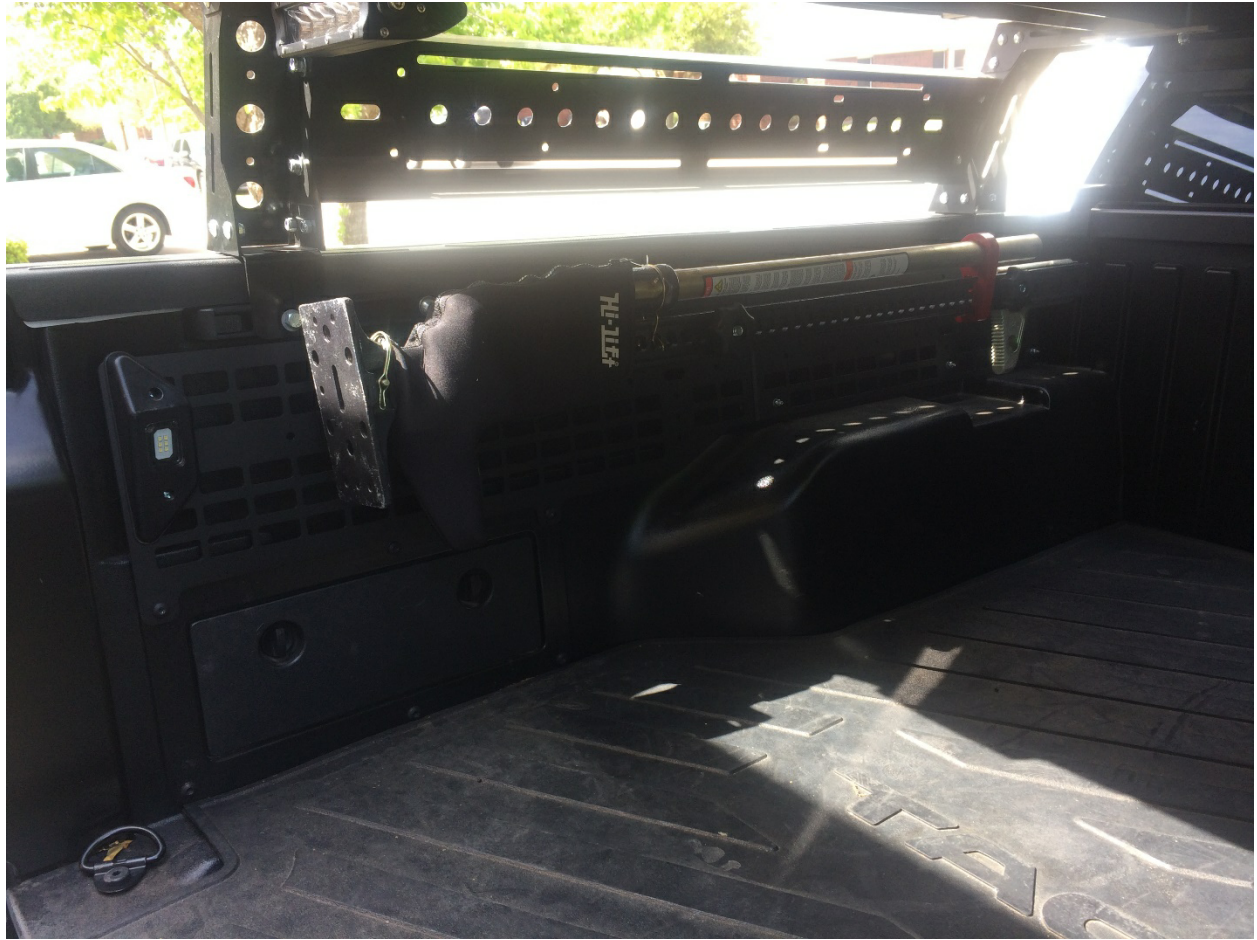
After the LED housing is torqued down, continue with the molle panel installation. Figure 11 shows the completed installation. Test to make sure that you LED still functions properly. And you are done. Took about 20 minutes for the entire install to include the LED housing relocation, but please take your time and attention to detail is the name of the game.

*Figure 11 - Completed Installation*
