Entune Audio Head Unit Software Update (Panasonic)

Service
Category Audio/Visual/Telematics

Navigation/Multi Info Display

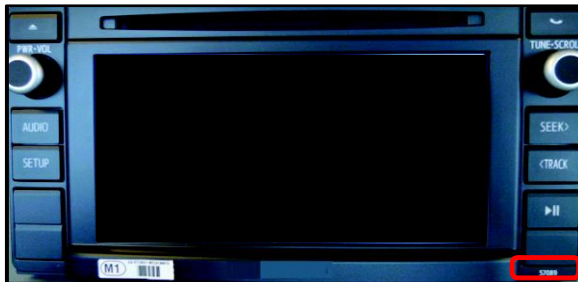
Figure 1. Avalon, Avalon HV, Highlander, Highlander HV, Prius, Prius V, Sienna, Sequoia, Tacoma, and Tundra

1. Confirm the audio system type by checking the faceplate ID printed on the bottom-right or bottom-center of the head unit. See Table 1 for the applicable model faceplate ID number.

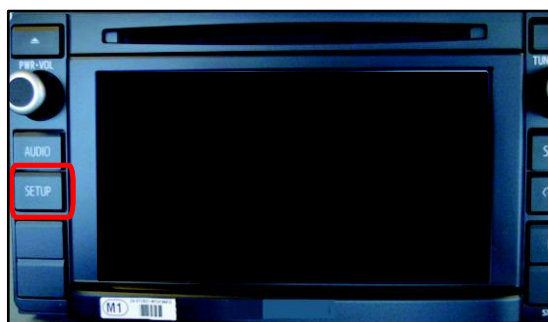
Figure 3. Tacoma, Prius, Prius V

2. Start the engine.
3. Insert the USB flash drive with the downloaded multimedia update file into the vehicle's USB port.
4. Go to the Setup screen.
 - A. For Entune™ Audio: Press the Setup button on the panel.

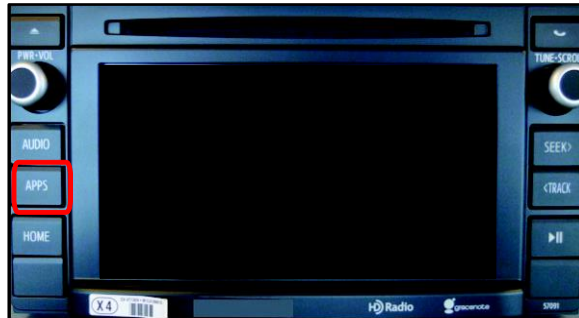
Figure 5. 4Runner, Avalon, Avalon HV, Highlander, Highlander HV, Prius, Prius V, Sienna, Sequoia, and Tacoma

- B. For Entune™ Audio Plus and Entune™ Premium Audio: Press the Apps button on the panel.

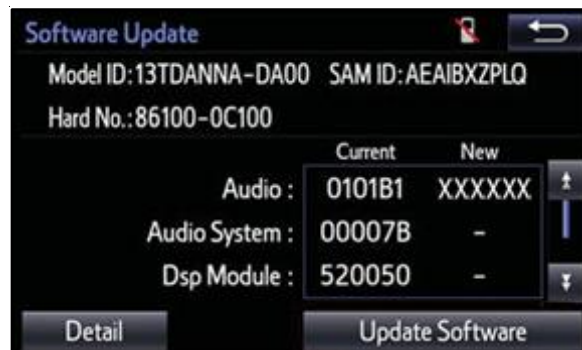
Figure 13.

9. Verify that the NEW software is up to date on the Software Update screen.

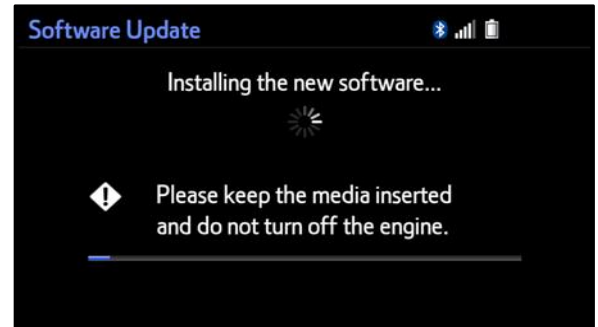
Figure 16.

12. The unit will begin installation. The update will take about 10 minutes.

- Do NOT turn off the engine or ACC before the software is ready for updating.
- Do NOT pull the USB flash drive out of the vehicle's USB port.

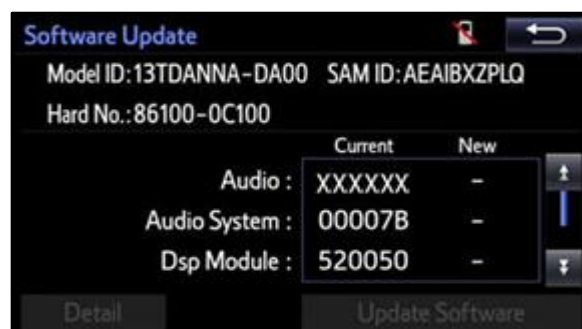
Figure 19.

1. Perform steps 3 – 7 of the Software Update Procedure to re-enter the Software Update screen.
2. Verify that the software information is updated on the Software Update screen. See Table 3 for the current software version.
