T-SB-0003-20  
January 13, 2020  
TOYOTA  
Technical Service Bulletin  
Entune Audio Head Unit Software Update (Panasonic)

## Entune Audio Head Unit Software Update (Panasonic)

Software Update Procedure

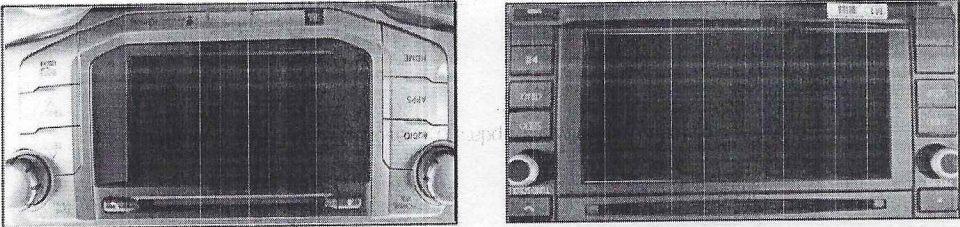
Figure 1. Avalon, Avalon HV, Highlander, Highlander HV, Prius, Prius V, Sienna, Sequoia, Tacoma, Tundra

1. Confirm the audio system type by checking the faceplate ID printed on the bottom-right or bottom-center of the head unit. See Table 1 for the applicable model faceplate ID number.

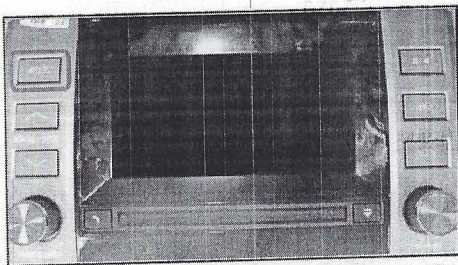
Figure 4. Tacoma, Prius V

4. Go to the Setup screen.
  - A. For Entune™ Audio: Press the Setup button on the panel.
  - B. For Entune™ Audio Plus and Entune™ Premium Audio: Press the Apps button on the panel.

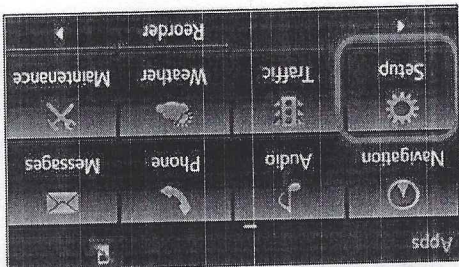
Figure 8.

5. Select Setup on the Apps screen.

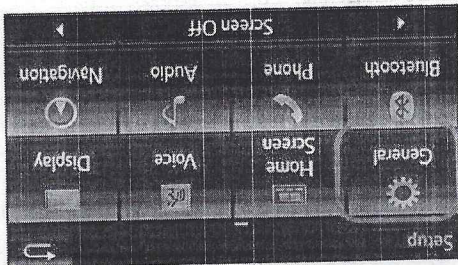
Figure 9.

6. Select General on the Setup screen.

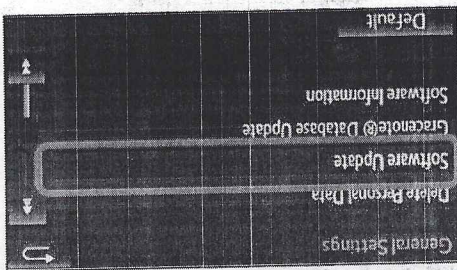
Figure 10.

7. Select Software Update from the list on the General Settings screen.

HINT  
Scroll down the list until Software Update displays.

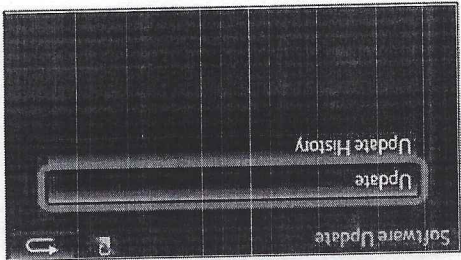
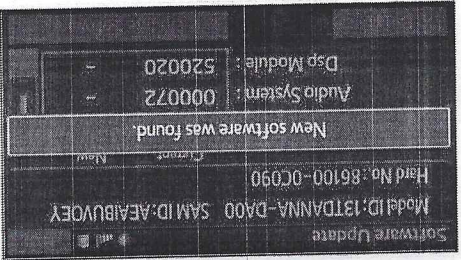
8. Select Update on the Software Update screen.

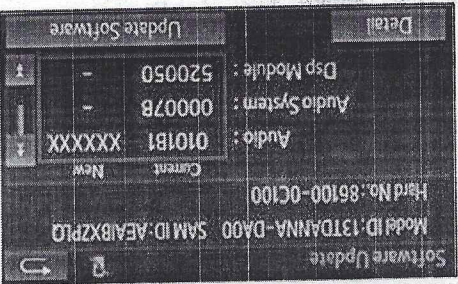
Figure 13.

9. Verify that the NEW software is up to date on the Software Update screen.

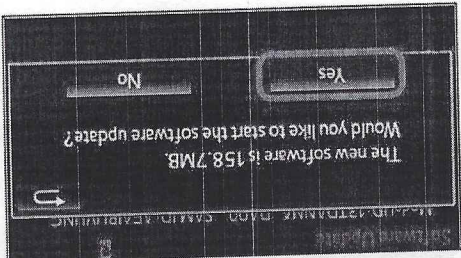
Figure 15.

11. Select Yes on the "Would you like to start the software update?" pop-up.

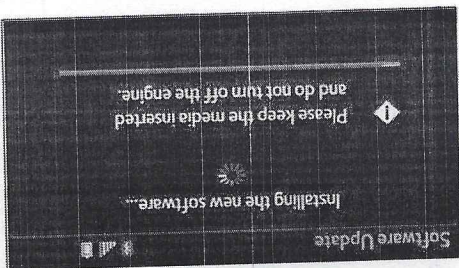
Figure 16.

12. The unit will begin installation. The update will take about 10 minutes.

- NOTE**
- Do NOT turn off the engine or ACC before the software is ready for updating.
  - Do NOT pull the USB flash drive out of the vehicle's USB port.

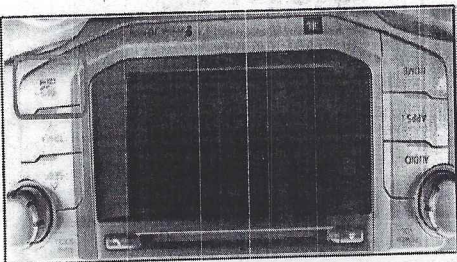
Figure 17.

- If the update fails and the error message "New software is not compatible with the system" displays, cycle the ignition OFF, remove the map micro SD card from the head unit, then repeat steps 3 – 12.
- A software update error is more likely to occur in areas with more traffic information.

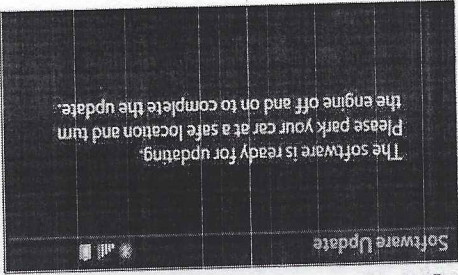
Figure 18.

13. When "The software is ready for updating" message displays, cycle the ignition OFF.

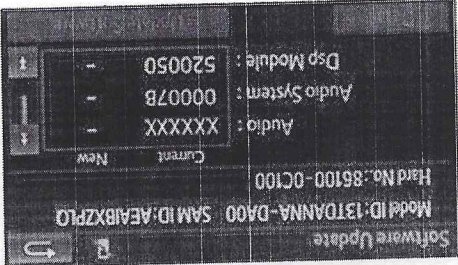
Figure 19.

- 1. Perform steps 3 – 7 of the Software Update Procedure to re-enter the Software Update screen.
- 2. Verify that the software information is updated on the Software Update screen. See Table 3 for the current software version.
